Levering Mill House: Cost Estimate

327 Levering Mill Road
Bala Cynwyd, Pennsylvania 19004

July 2017

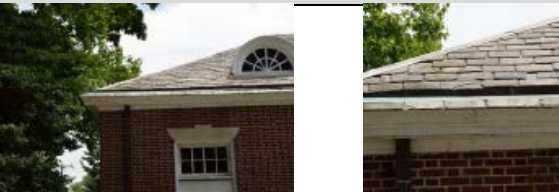
<--- Excerpt From "Levering Mill House, Inventory of Remedial Work as of 07/03/14" --->				Repair Category	Comments
19	West Facade	Replace broken (slate) roof tile.

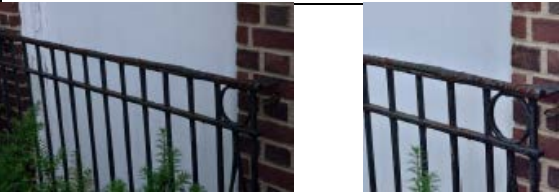
Building Envelope: Roof	
20	West Facade	Scrape & paint 4 iron Juliet balcony railings.

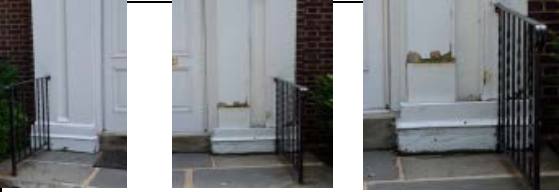
Building Envelope: Railings	
21	West Facade	Remove & replace wood pilasters next to entry door.

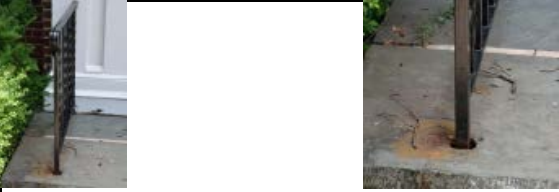
Building Envelope: Exterior Doors	
22	West Facade	Secure iron railings, both sides of door.

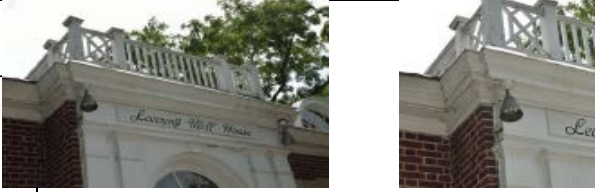
Building Envelope: Railings	
23	West Facade	Repair roof leak that is causing deterioration of wood entry trim shown (in 21) above.

Not Applicable	As of January 2017, it was reported that prior roof repairs were performed and there are no active roof leaks.
24	West Facade	Repair & repaint left end of cornice.
